# Manhole Inspection Summary

Manhole # S41A2\_005MH

Insp Date: **4/22/08 12:41 PM**

**Location** Address: **3725 8th St.**

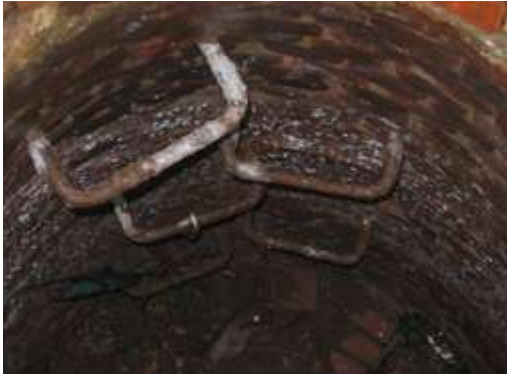
Count: **5** Missing: **0** ☒ **Corroded**

steps

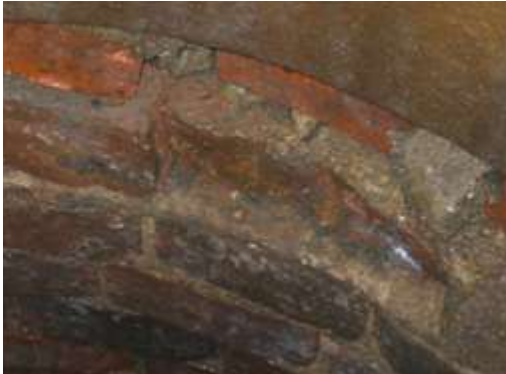
Defect 1

Condition: ☐ Sound ☒ **Cracked** ☐ Root Intrusion ☒ **Loose Brick** ☐ Deteriorated

Infiltration: ☐ None ☒ **Joint** ☒ **Cracks** ☐ Mortar ☐ Roots ☐ Wall

loose bricks

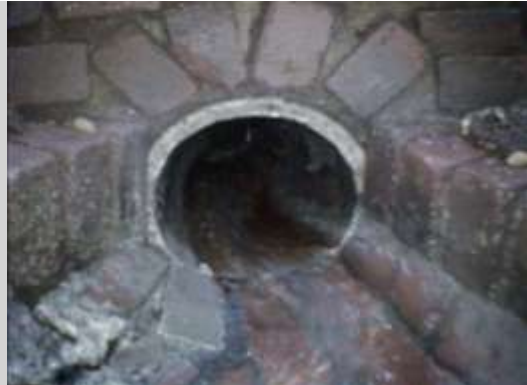
12 O'Clock Outflow

Pipe Height: **10.8** (in.) Rod and Bar (Angled)  
Pipe Material: **Clay** ☐ Pipe Lined  
Invert Depth: **10.84** (ft.) Flow Characteristics: **Fast**  
Deposits: ☒ None ☐ Mud ☐ Sludge ☐ Debris ☐ Grease  
Silt Depth: (in.) Deposits Extent:  
Infiltration: **None** Pipe Seal Cond: **Sound**

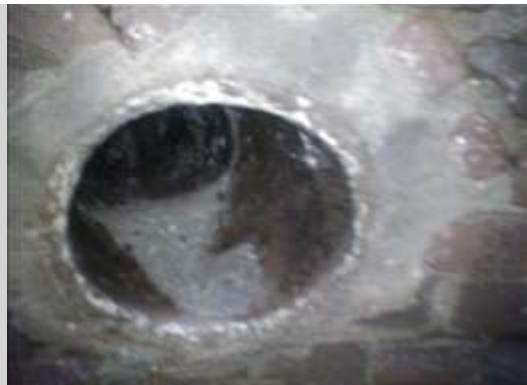
4 O'Clock Inflow

Pipe Height: **9.6** (in.) Rod and Bar (Angled)  
Pipe Material: **Clay** ☐ Pipe Lined  
Invert Depth: **7.74** (ft.) Flow Characteristics: **Fast**  
Deposits: ☒ None ☐ Mud ☐ Sludge ☐ Debris ☐ Grease  
Silt Depth: (in.) Deposits Extent:  
Infiltration: **None** Pipe Seal Cond: **Sound**

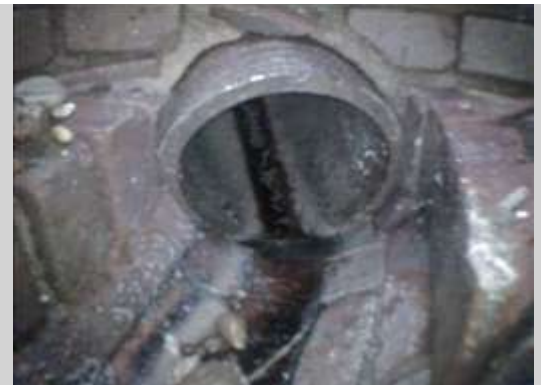
Drop In @ 4 O'Clock

Drop: **Outside** Rod and Bar  
Angled: **Yes** Reading: **9.26** (ft.)  
Inv Depth: **10.26** (ft.)  
Drop Condition: **Open**

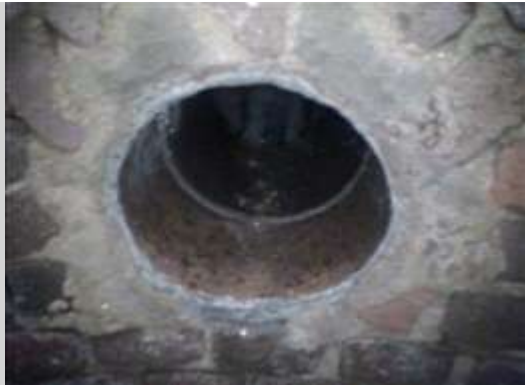
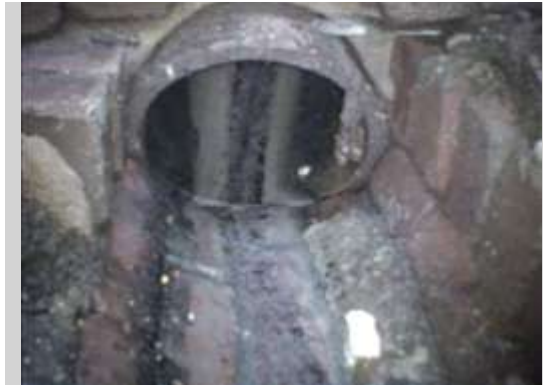
6 O'Clock Inflow

Infiltration: **None** Pipe Seal Cond: **Sound**

Drop: **Outside** Rod and Bar  
Angled: **Yes** Reading: **9.28** (ft.)  
Inv Depth: **10.28** (ft.)  
Drop Condition: **Open**

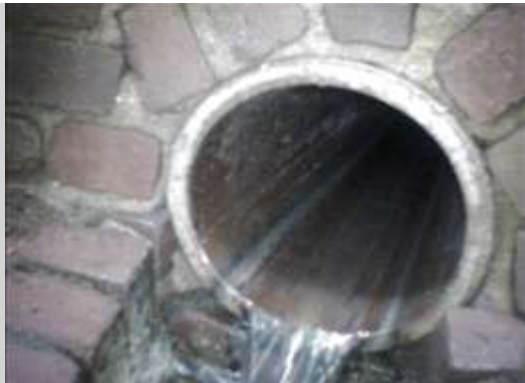
9 O'Clock Inflow

Infiltration: **None** Pipe Seal Cond: **Sound**
